Introduction

- In the offshore industry, high-strength steels are prone to Hydrogen Embrittlement (HE).
- HE causes a permanent loss of ductility leading to corrosion and cracking.
- Acoustic Emission sensors placed on a structure can be used to detect, locate and characterize damage.

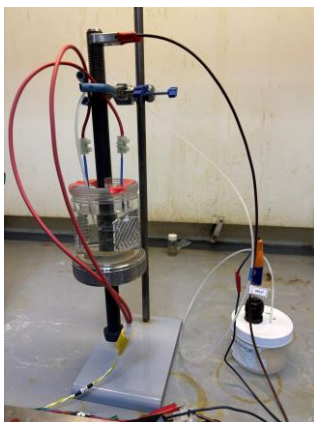
Figure 3- Experimental set-up of hydrogen charging

- 3.5% Sodium Chloride and 3 g/L Ammonium Thiocyanate charging solution used.
- Specimens charged with current density of 10 mA/cm²
- Charging time of 48 hours.

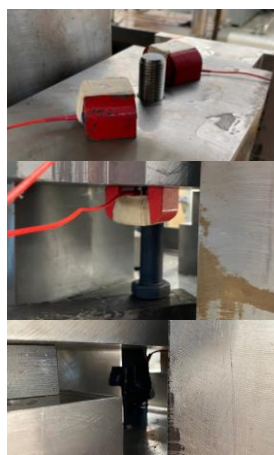
Figure 7- Mounting of the 4 sensors on the rig

- 4 nano 30 sensors placed on the rig
- Frequency response between 125 to 750 Hz
- A gel-based couplant was used to mount the sensors
